HOME INSPECTION REPORT

874 Summit Pkwy
Bostic , Nc 28018

Nico Toma
08/05/2025

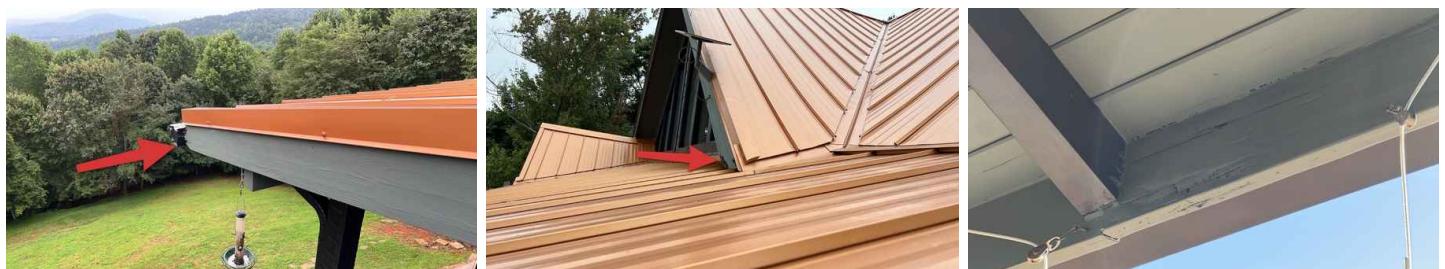
DECAYED/DAMAGED - LOCATIONS

There was decayed/damaged wood/trim that was readily visible on the location(s) listed above on the exterior of the house. The decayed/damaged wood/trim can allow water infiltration, which could cause decay of the structural components behind the cladding. There could be hidden damage in these areas. There could be other areas of decay on the exterior of the house. All of the decayed wood/trim on the exterior of the house needs to be repaired/replaced by a qualified contractor.

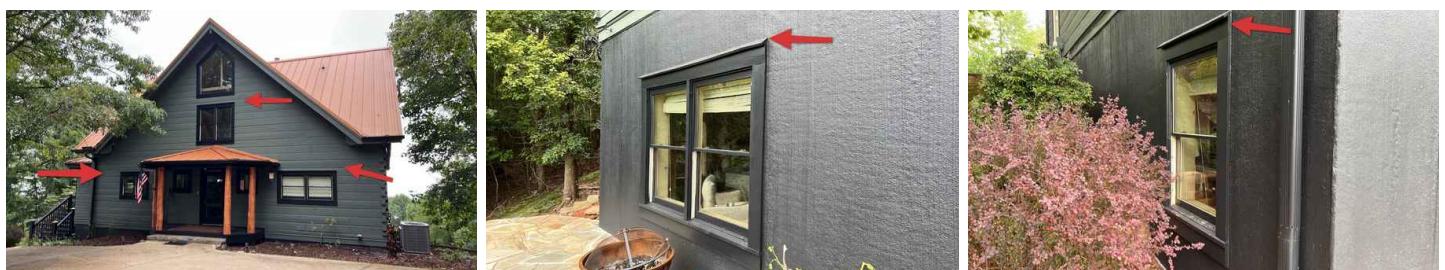
3.5.1 Wall Flashings

There was no visible flashing installed at horizontal transitions in the location(s) listed above on the exterior of the house. This can allow water infiltration, which could cause decay. There could be hidden damage in those area(s). The area(s) need to be repaired by a qualified contractor.

No flashing with wood rot at window

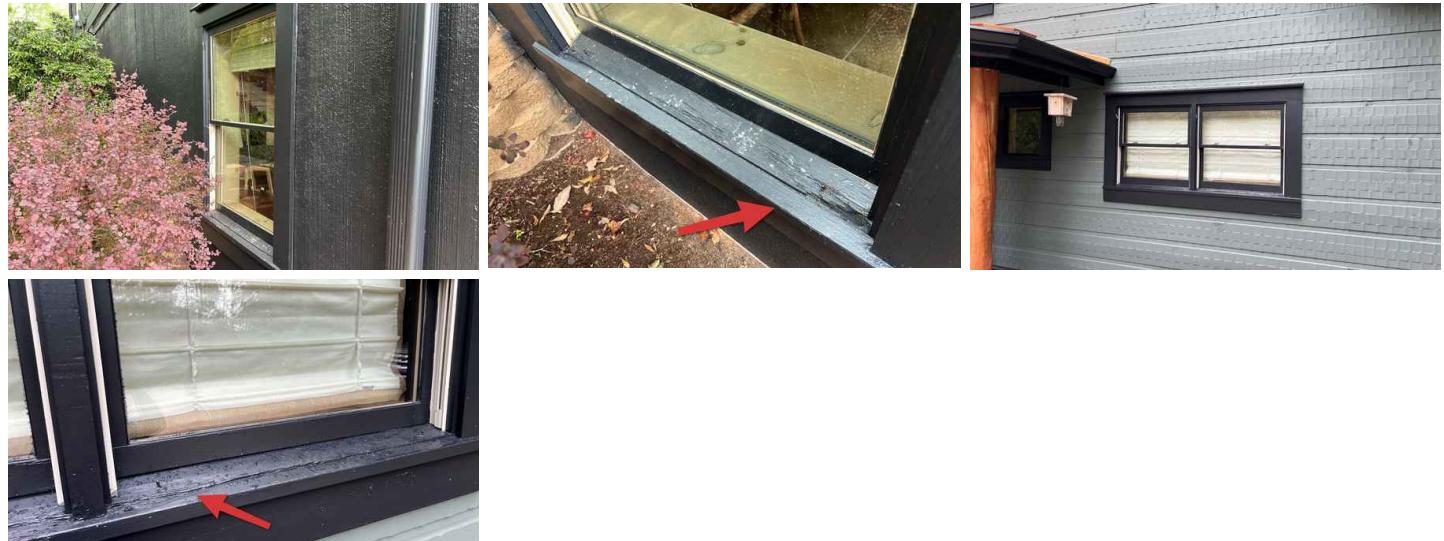
3.7.1 Exterior Windows

DECAY ON WINDOW

There was decayed wood on the window in the location(s) listed above. This can allow water infiltration and could allow airflow around the window. There could be hidden damage in those areas. The area(s) need to be repaired/replaced by a qualified contractor.

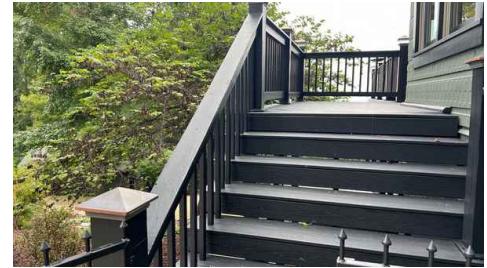
3.9.1 Steps/Rails

HAND RAIL NOT GRIPPABLE

The handrail(s) on the steps in the location(s) listed above were too big/wide and were not grippable, which creates tripping/falling hazards. The rail(s) need to be repaired/replaced by a qualified contractor.

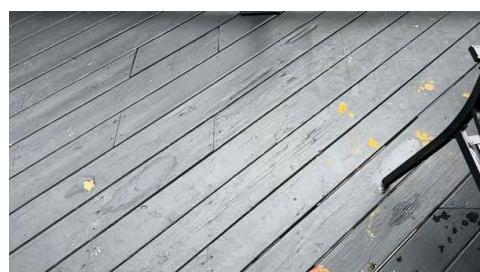
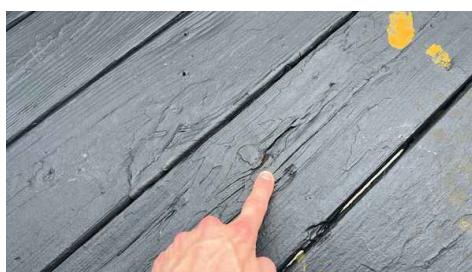
3.10.1 Deck

WORN WOOD

There was worn wood on the deck floor/steps/rails. The worn wood on the floor and steps could fail/break when walked on. The worn wood on the rails could scratch/splinter a person. The deck needs to be repaired/replaced by a qualified contractor.

Section with decay

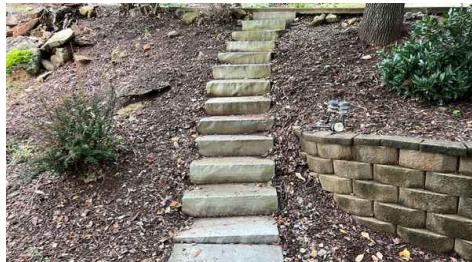
The step height of the steps at the patio and exterior stairs was too tall with uneven surfaces and the step height was not consistent. These issues create tripping/falling hazards. The steps need to be repaired/replaced by a qualified contractor.

Uneven steps and too much high change

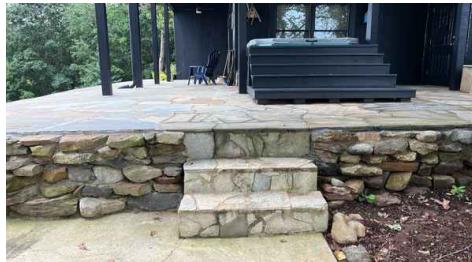
Steps height too tall

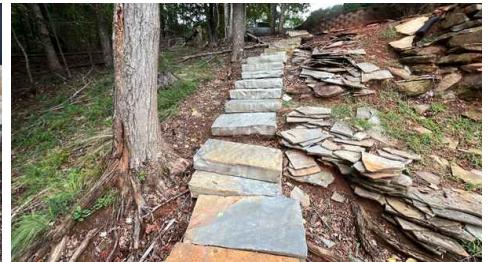
Uneven and loose steps

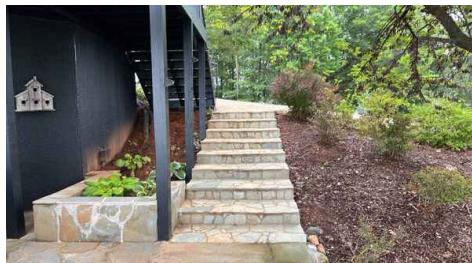
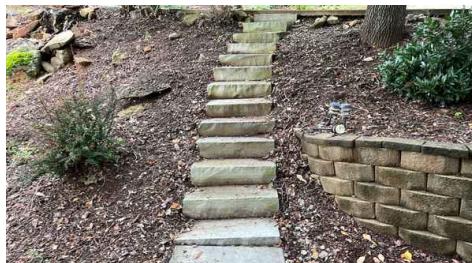
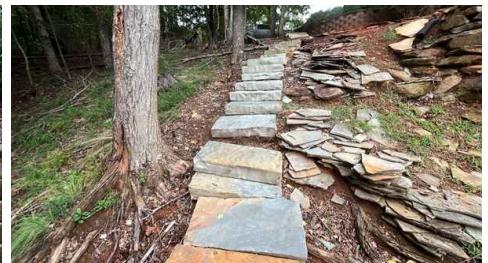
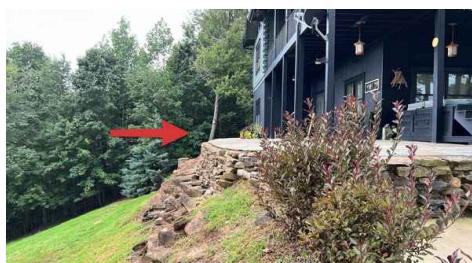
3.13.2 Patio

Defect
NO RAILS

There were no rails on the patio and steps near the patio. The patio was high off of the ground at the location(s) listed above. A person could fall off of the patio or fall on the steps around the patio and be injured. Rails need to be installed by a qualified contractor.

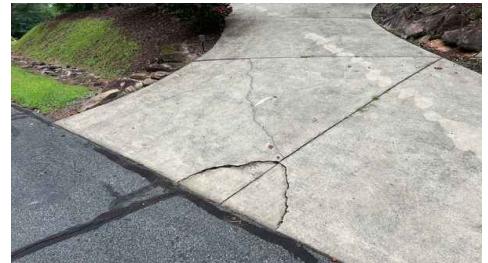
3.15.1 Driveway

Defect
CRACKS WITH HEIGHT CHANGE

There were cracks in the driveway that had height changes, which can indicate movement occurring in/under the driveway and creates tripping hazards. The driveway needs to be repaired/replaced by a qualified contractor.

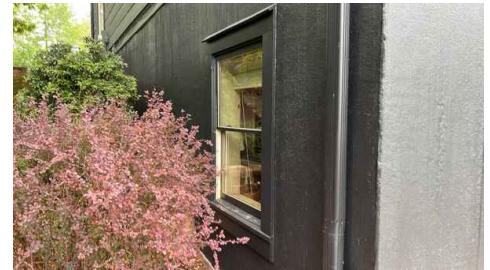
3.20.1 Vegetation

BUSHES/TREES

There were bushes/trees around the house that were touching the house/roof and that limited the view of the house. This can foster decay and pests and could damage the shingles. There was limited view of the exterior of the house during the inspection. There could be hidden damage to the exterior of the house behind the vegetation. The bushes/trees need to be repaired by a qualified contractor and the exterior of the house needs to be fully inspected.

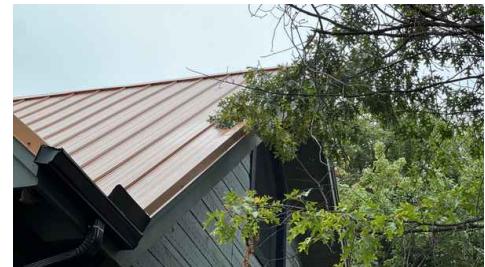
There were tree(s) touching the roof, which could damage the shingles and limit the view of the roof. There could be hidden damage to the roof. Be sure to keep the tree(s) cut away from the roof/house. The roof needs to be evaluated by a qualified contractor and repaired/replaced as necessary.

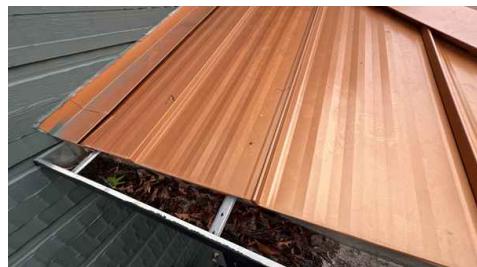
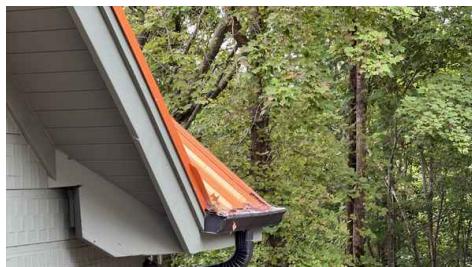
4.2.1 Drainage System

DEBRIS

There was visible debris in the gutters, which can allow them to overflow. Overflowing gutters could cause decay, especially to the wood behind the gutters. Overflowing gutters can also cause moisture problems with the foundation/crawl space. The gutters need to be repaired by a qualified contractor.

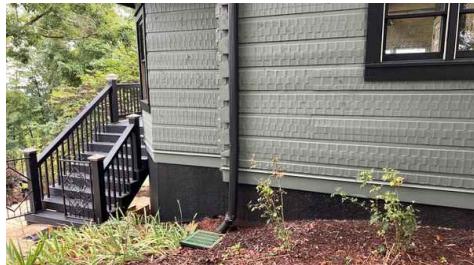
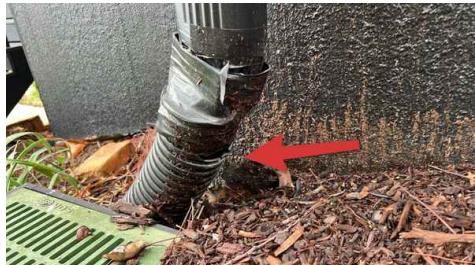
4.2.2 Drainage System

**BENT/DAMAGED DOWNSPOUT**

The downspout(s) in the location(s) listed above were bent/damaged, which can restrict water flow out of the downspout and cause the gutter to overflow. The downspout(s) need to be repaired/replaced by a qualified contractor.

Hole

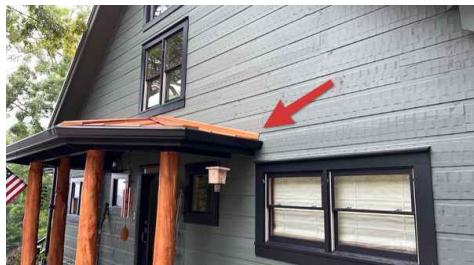
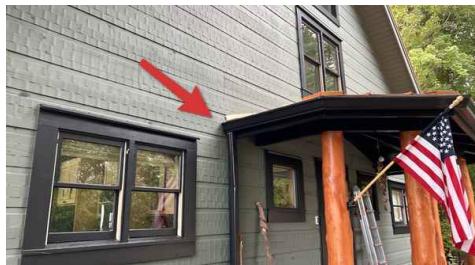
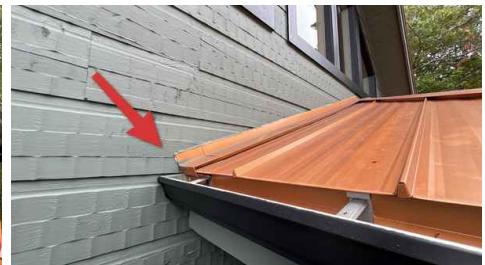
4.3.1 Roof Flashings

There was no visible kick-out flashing on the location(s) listed above. Kick-out flashing is used to keep water that is running down the roof from running behind the siding. The lack of kick-out flashing could allow water infiltration into the wall, which could cause decay. There could be hidden damage in those areas. Those areas need to be repaired by a qualified contractor.

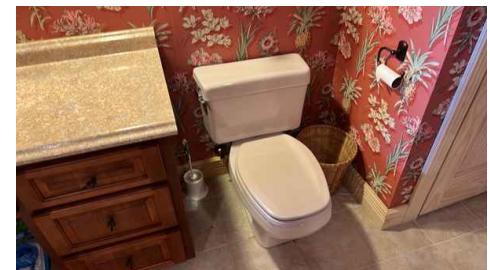
TOILETS LOOSE

The toilet in the bathroom(s) listed above was loose where it connected to the floor. Thus, the toilet would move, which could damage the toilet and/or allow water leaks. The toilet(s) need to be repaired by a licensed plumbing contractor.

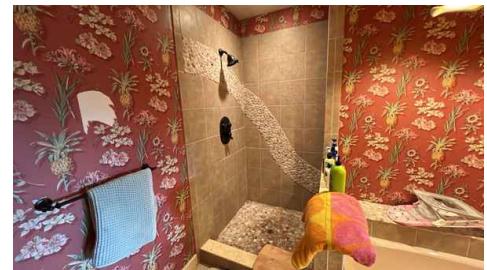
5.11.1 Bathroom Tubs/Showers

There was no enclosure around the shower in the bathroom(s) listed above. This will allow water to splash out of the shower. The shower head in that shower was fully tested. Enclosure(s) need to be installed by a qualified contractor.

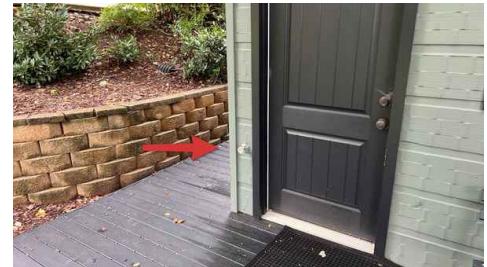
5.14.1 Exterior Fixtures

The hose bib(s) in the location(s) listed above on the exterior of the house did not work. Thus, the hose bib could not be used/tested. The hose bib(s) need to be repaired/replaced by a licensed plumbing contractor.

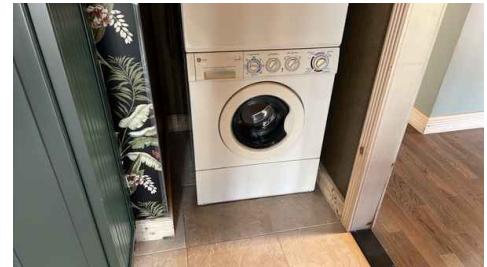
5.16.1 Laundry Tub

There was no laundry tub in the laundry room/closet and there was finished/conditioned space below the laundry room. A laundry tub is not a required item but many builders install it. A laundry tub sits under a clothes washer and has a drain pipe flowing to the ground. Thus, any leaks from the clothes washer cannot be handled. The laundry leak/overflow protection needs to be repaired/replaced by a licensed plumbing contractor.

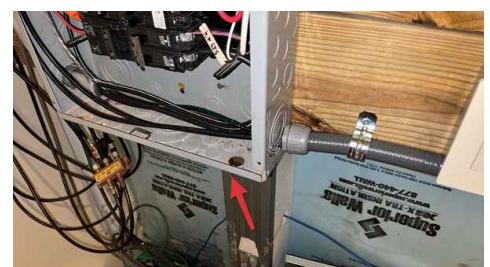
There were hole(s) in the electrical distribution panel in/on the location(s) listed above. The hole(s) can allow animals to enter the panel, which could damage the electrical components in the panel. The hole(s) can allow oxygen to enter the panel, which could feed a fire inside the panel. The panel needs to be repaired by a licensed electrical contractor.

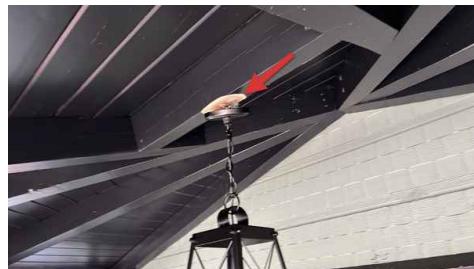
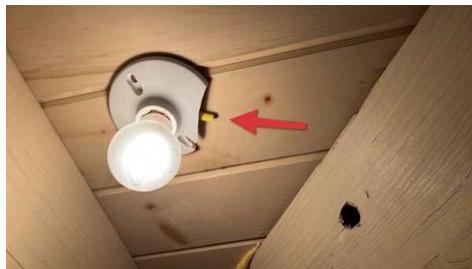
6.6.1 Circuit Conductors

OPEN JUNCTIONS

There were open electrical junctions in the location(s) listed above. Open electrical junction(s) create shocking hazards. The electrical junction(s) need to be repaired by a licensed electrical contractor.

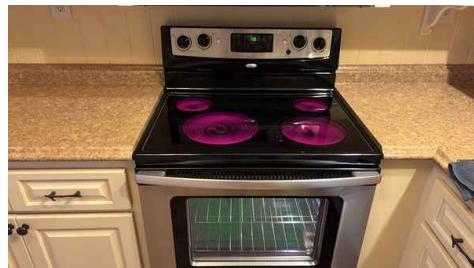
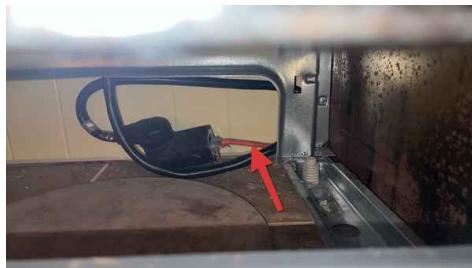
6.6.2 Circuit Conductors

EXPOSED NM CABLE INSIDE

There were exposed nonmetallic (NM) sheathed cable(s) in the location(s) listed above. NM cable is allowed to be exposed in unfinished spaces such as the attic and crawl space. However, it is supposed to be protected/concealed inside the house/garage. The NM cable could create a shocking hazard if it is damaged. The exposed NM cable(s) need to be repaired by a licensed electrical contractor.

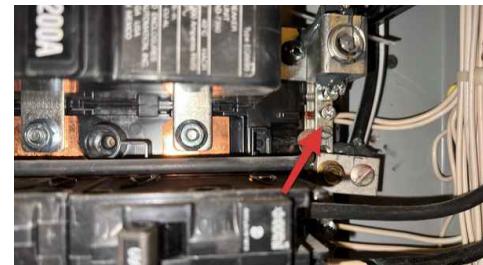
6.6.3 Circuit Conductors

TWO NEUTRALS UNDER LUG

At the main electrical panel, two neutral conductors were observed terminated under a single lug. Multiple conductors under one terminal can lead to loose connections and arcing. Recommend further evaluation and correction by a licensed electrical contractor.

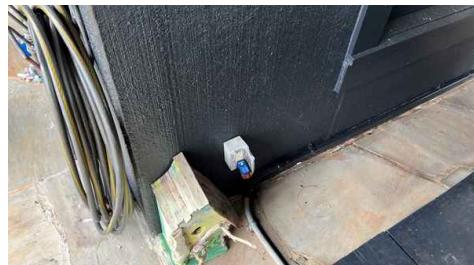
Patio

The receptacle(s) in the location(s) listed above had no power and could not be used. The receptacle(s) need to be repaired by a licensed electrical contractor.

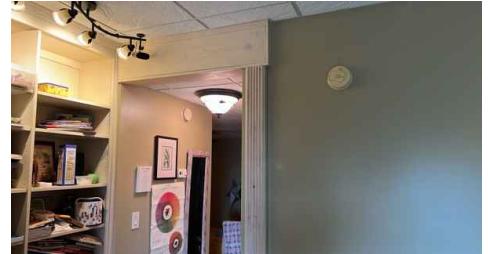
6.12.1 Smoke/Carbon Monoxide Detectors

The smoke and/or Carbon Monoxide (CO) detectors were older. Manufacturers typically recommend that detectors be replaced every ten years. The older detector(s) may not work properly, which would create fire/health hazards. The detector(s) need to be evaluated/repaired/replaced by a licensed electrical contractor.

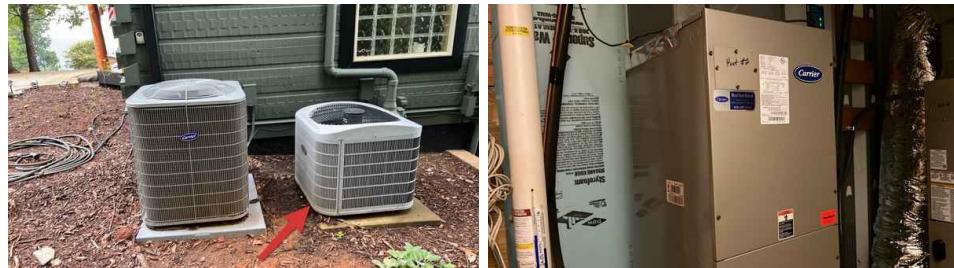
The HVAC system (inside and outside units) for the location(s) listed above was older and could be near the end of its useful life. The HVAC system operated normally during the inspection. The HVAC system needs to be evaluated by a licensed mechanical contractor and repaired/replaced as necessary.

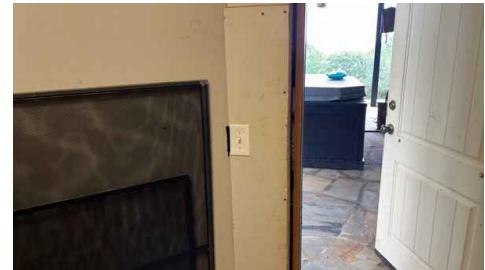
There was damage to the wall/interior trim in the location(s) listed above. The damage appeared to be caused by a wood-destroying organism. There could be hidden damage in that area. That area needs to be evaluated and repaired by a licensed general contractor. This inspection does not provide an evaluation of any wood-destroying organisms. Contact a licensed pest inspector for more information.

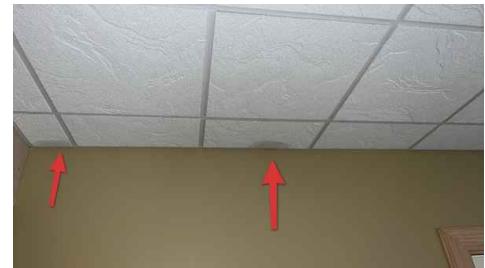
There were stains on the ceiling in the location(s) listed above. The stains indicate water infiltration and/or a leak at some time in the past. The area(s) appeared to be dry during the inspection. There was no view of the attic and/or structural components in those area(s). There could be hidden damage in those area(s). The area(s) need to be repaired by a qualified contractor.

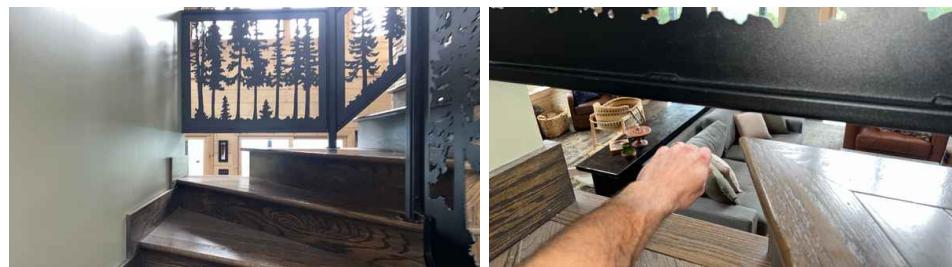
8.7.1 Railings

SPACING TO LARGE

The spacing at an interior handrail on the location(s) listed above was too big. Big openings in the guardrails on interior stairs and can allow a child to crawl through and get injured. Recommend correction by a qualified contractor.

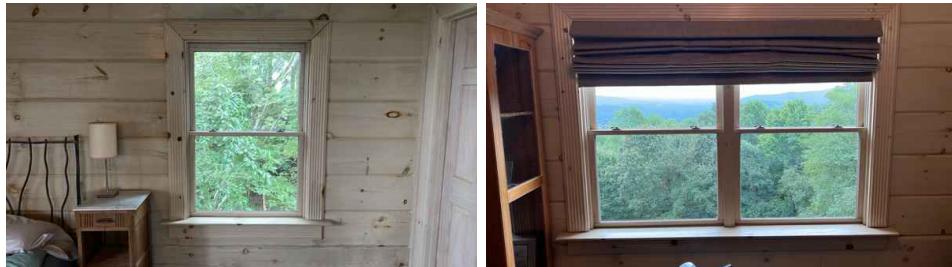
8.10.1 Interior Windows

Window(s) in the room(s) listed above were stuck shut and would not open. Thus, the windows could not be used/tested. Windows are used as emergency exits, especially from bedrooms. The window(s) were marked with green tape. The window(s) need to be repaired/replaced by a qualified contractor.

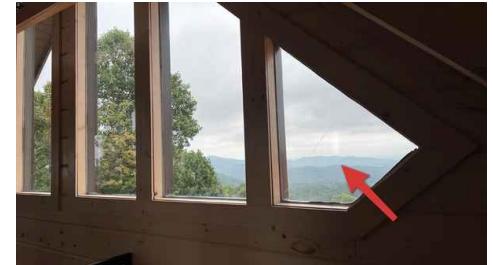
8.10.2 Interior Windows

Window(s) in the location(s) listed above had broken glass. The broken glass could injure a person. The window(s) were marked with green tape. The damaged window(s) need to be repaired/replaced by a qualified contractor.
