TRUE VIEW PROPERTY INSPECTIONS LLC

RESIDENTIAL INSPECTION

874 Summit Pkwy
Bostic , Nc 28018

John Doe
08/05/2025

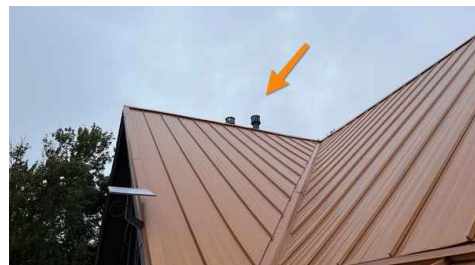
CHIMNEY FLASHING INSPECTION LIMITATION

The chimney roof penetration could not be inspected due to limited roof accessibility. Its condition could not be confirmed. If concerns arise or signs of leakage develop, further evaluation by a qualified roofing contractor is recommended.

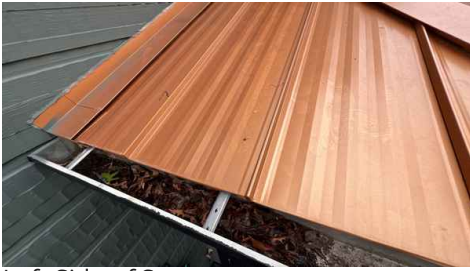
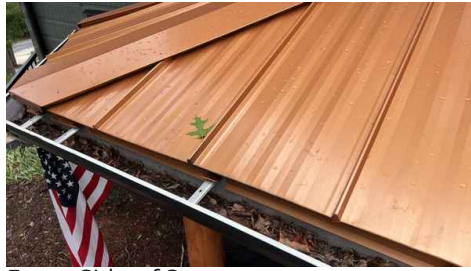
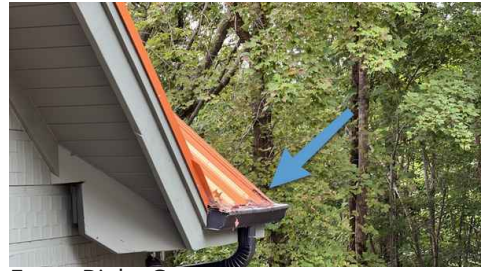
2.2.1 Roof Drainage Systems

Debris has accumulated in the gutters. This condition affects the proper shedding of water from the structure which can lead to water accumulating in areas around the structure, such as around the foundation, which can cause additional damage. Recommend cleaning to facilitate adequate water flow.

Contact a handyman or DIY project

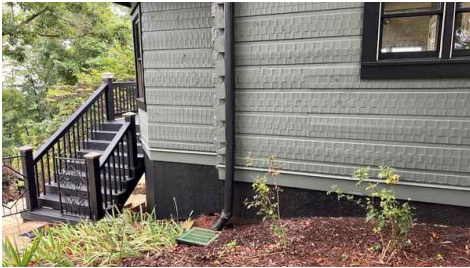
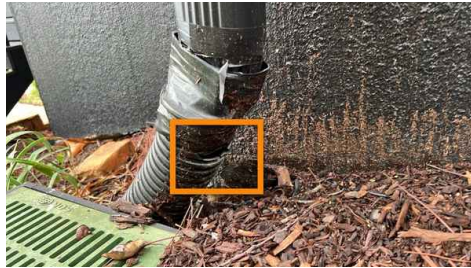
2.2.2 Roof Drainage Systems

DOWNSPOUT DAMAGED

Minor Defect

One downspout was damaged. This condition can restrict proper drainage away from the structure which can contribute to soils erosion and future foundation concerns. Repair or replacement by a qualified contractor is recommended.

Contact a qualified gutter contractor

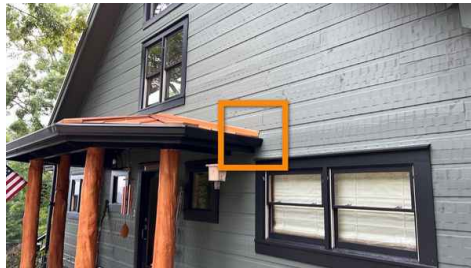
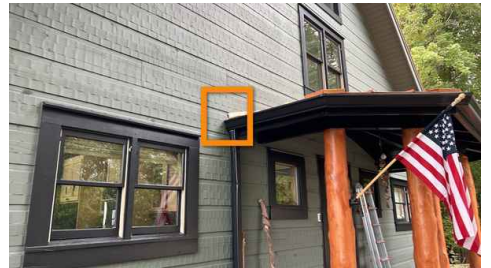
2.2.3 Roof Drainage Systems

MISSING KICKOUT DIVERTER

Minor Defect

A kick out diverter was not installed where the roof edge meets the wall. Kick out flashing helps direct roof runoff away from siding and into the gutter system. Without it, water can flow behind the siding and trim, potentially leading to moisture intrusion, hidden damage, or deterioration of building materials. Installation of a proper diverter by a qualified contractor is recommended to help protect the structure from water damage.

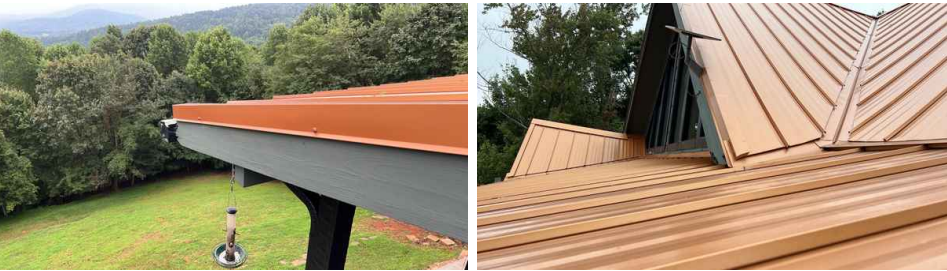
TRIM DAMAGE

Trim damage was observed during the exterior inspection. This can cause potential moisture intrusion or structural wear. If left unaddressed, damaged trim can allow water penetration, leading to wood rot, pest entry, and potential structural deterioration. Recommend further evaluation by a carpentry contractor and correction of damaged trim sections to prevent further damage.

Contact a qualified carpenter.

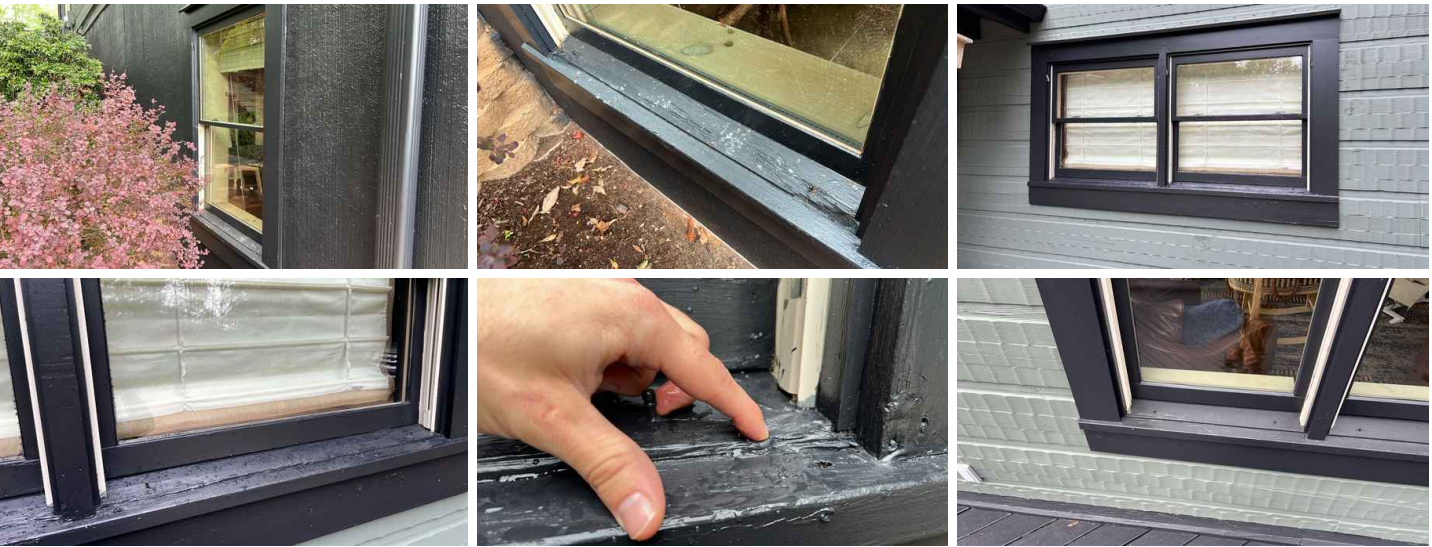
3.2.2 Siding, Flashing & Trim

ROT AT WINDOW TRIM

Exterior window trim showed signs of rot and deterioration. This damage was discovered during the exterior inspection, potentially exposing underlying wood to moisture intrusion. Continued rot can lead to structural weakness and potential water damage to the surrounding building materials. Recommend correction by a qualified window repair and installation contractor.

Contact a qualified window repair/installation contractor.

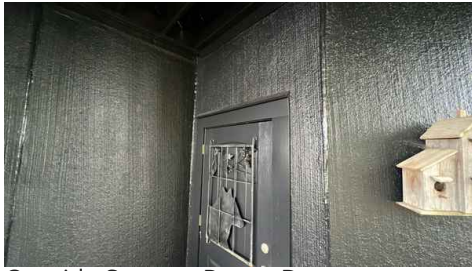
3.3.1 Exterior Doors

NO FLASHING ABOVE DOOR

No flashing was discovered above the exterior door during inspection. This installation oversight creates potential water intrusion risks, allowing moisture to penetrate behind the door frame and potentially damage structural components. Water can seep into wall cavities, leading to wood rot, mold growth, and compromised structural integrity. Recommend correction by a qualified contractor.

Contact a qualified door repair/installation contractor.

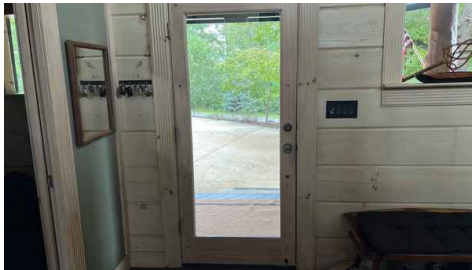
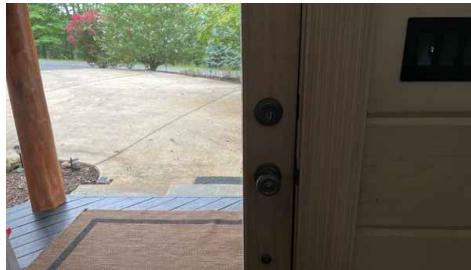
The front door is a keyed deadbolt door with no other ways to open the door without the required key. This is a safety hazard because it can restrict quick egress in the case of an emergency. Recommend correction by a qualified locksmith.

Contact a qualified professional.

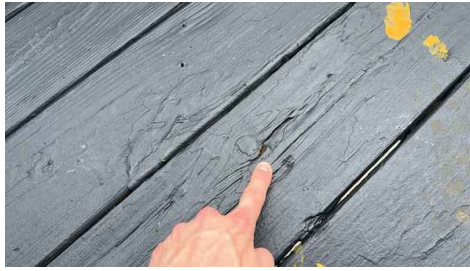
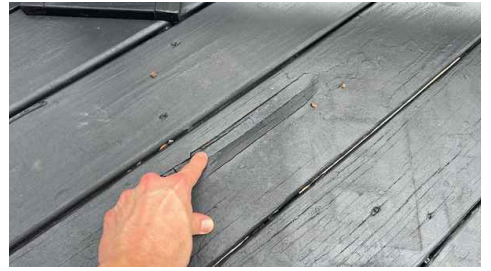
3.4.1 Decks, Balconies, Porches & Steps

ROTTED DECK BOARDS

Deck boards had wood deterioration and rot. These boards were discovered during a visual inspection of the deck surface, indicating prolonged moisture exposure and potential structural compromise. Wood rot can lead to safety hazards, reduced structural integrity, and potential failure if left unaddressed. Recommend replacement of damaged boards by a qualified deck contractor.

Contact a qualified deck contractor.

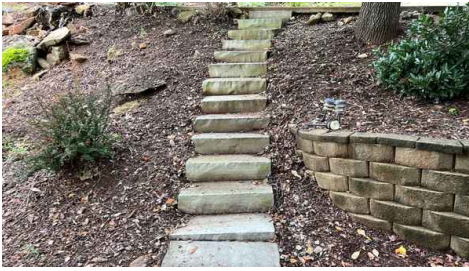
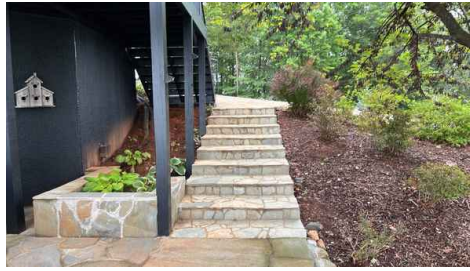
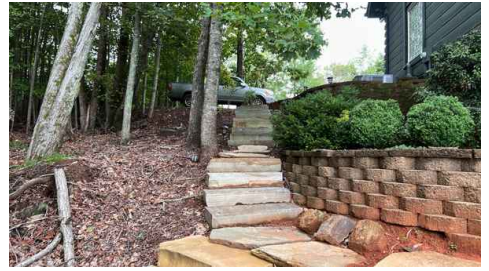
3.4.3 Decks, Balconies, Porches & Steps

MISSING HANDRAILS

Exterior steps and elevated surfaces without required safety handrails were discovered during the inspection. This condition creates a fall hazard for individuals using these areas, particularly for elderly or mobility-impaired persons. Proper handrail installation is crucial for preventing potential injuries and ensuring safe navigation. Recommend correction by a qualified contractor.

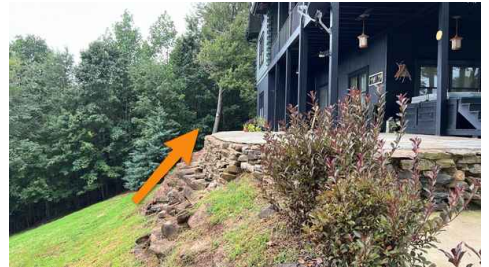
3.4.4 Decks, Balconies, Porches & Steps

MISSING GUARDRAILS

Deck guardrails are a critical safety component designed to prevent falls from elevated surfaces. The absence of guardrails creates a fall hazard, especially for children, elderly, or individuals with limited mobility. Safety standards typically require guardrails for decks, balconies, and porches elevated more than 30 inches above ground level. Installation of guardrails is recommended to prevent potential injury.

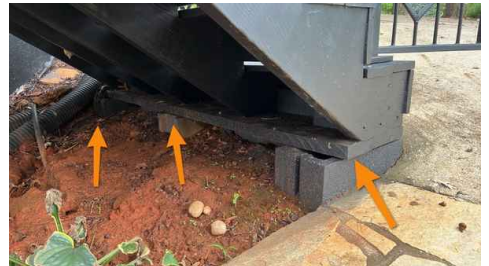
3.4.5 Decks, Balconies, Porches & Steps

NO FLASHING AT STAIR SUPPORT

Stone was observed in direct contact with wood at the deck stair support structure, and no flashing was installed between the materials. This condition can trap moisture against the wood, leading to deterioration and potential weakening of the structural support. Further evaluation and correction by a qualified general contractor is recommended.

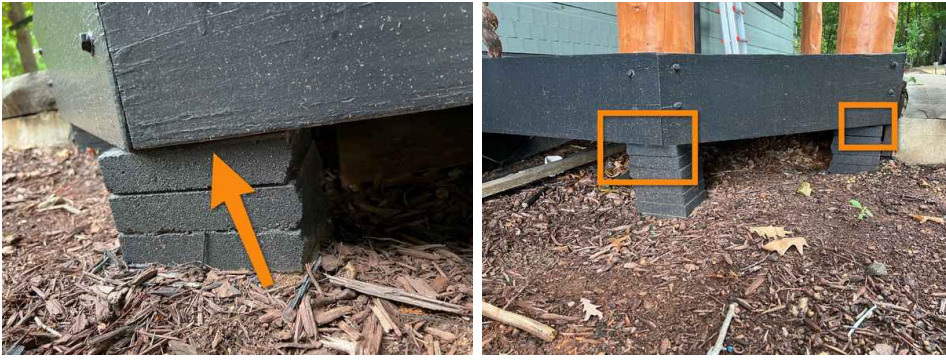
3.4.6 Decks, Balconies, Porches & Steps

NO FLASHING AT SUPPORT

Stone was observed in direct contact with wood at the front porch support structure, and no flashing was installed between the materials. This condition can trap moisture against the wood, leading to deterioration and potential weakening of the structural support. Further evaluation and correction by a qualified general contractor is recommended.

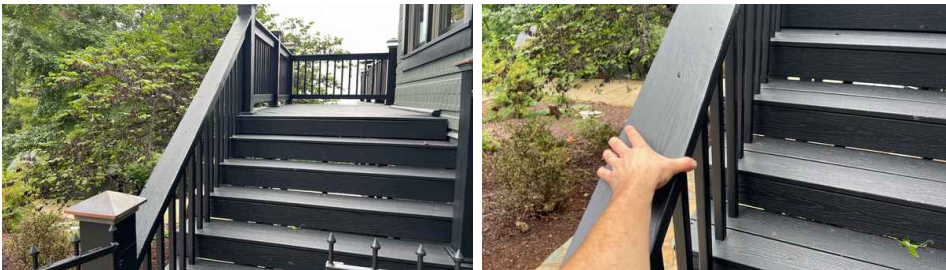
3.4.7 Decks, Balconies, Porches & Steps

The handrail at the exterior stairs was not grippable. Handrails should be shaped and sized to allow a secure grip; excessively wide or improperly contoured handrails can prevent proper hand placement. This condition presents a fall hazard, especially for elderly individuals or those with limited mobility. Recommend correction by a qualified general contractor.

Contact a qualified general contractor.

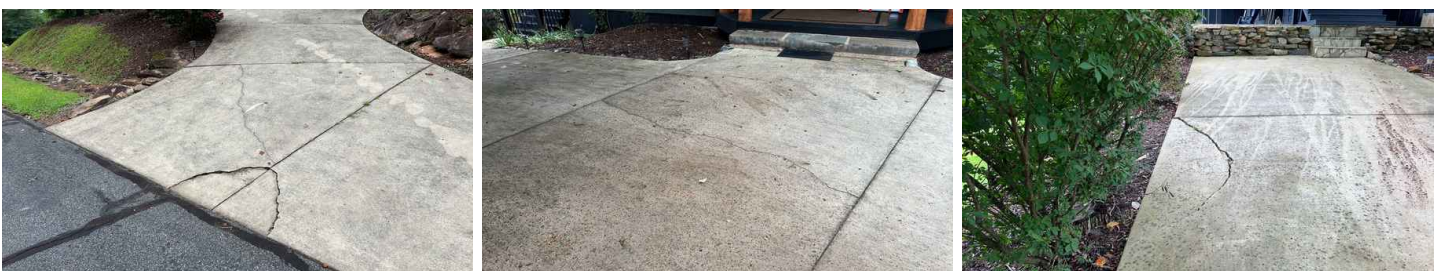
3.6.1 Walkways, Patios & Driveways

DAMAGED DRIVEWAY

Concrete or asphalt surface showed signs of damage during exterior inspection. Surface cracks, potential structural deterioration, and uneven areas create potential tripping hazards and may indicate underlying ground movement. Professional evaluation recommended to determine repair strategy and prevent further degradation.

Contact a qualified driveway contractor.

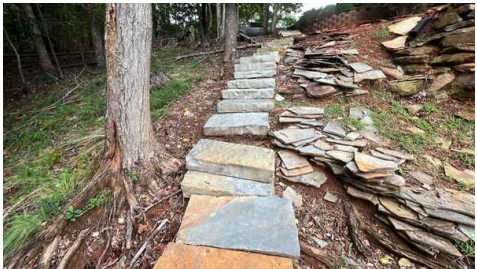
3.6.2 Walkways, Patios & Driveways

DAMAGED WALKWAY STEPS

Contact a qualified professional.

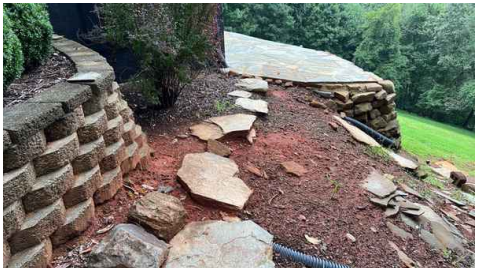
Uneven walkway was observed during the inspection. Walkways should have level surfaces for safe use. The uneven walkway is a potential fall hazard. Recommend correction by a qualified landscaping contractor or masonry contractor.

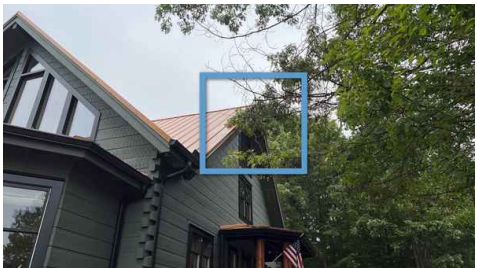
3.7.1 Vegetation, Grading, Drainage & Retaining Walls

TREE OVERHANG AND CONTACT

Tree limbs were observed to be in contact with the roof. The tree limbs can damage the roof system and introduce pests onto the roof which can cause further damage. Regular tree maintenance helps mitigate potential structural and property damage risks. Recommend correction by a qualified tree trimming contractor.

Contact a qualified professional.

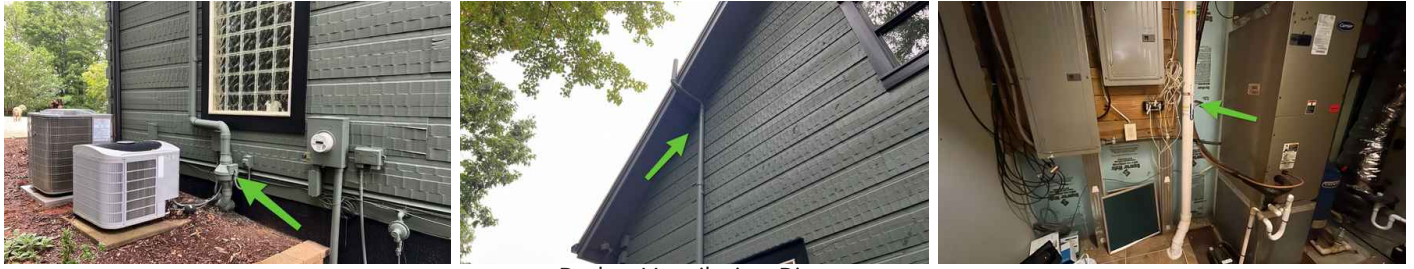
Radon Ventilation Pipe

A Radon mitigation system is installed in this home. Similar to a HVAC system, radon mitigation systems require annual maintenance and fan service/replacement every 5 years. The inspection of the mitigation system, including the determination of the functionality and or the effectiveness, is beyond the scope of the home inspection. The homeowner should be asked for more information concerning system warranties and maintenance history. A qualified radon mitigation specialist should be consulted for a complete system evaluation.

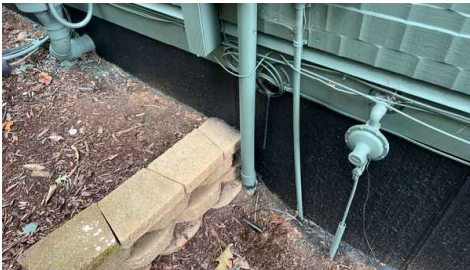
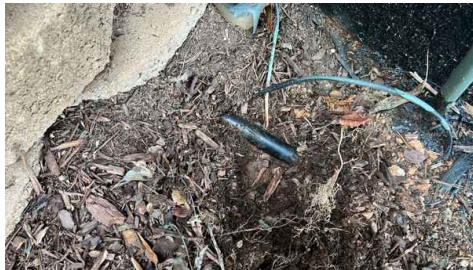
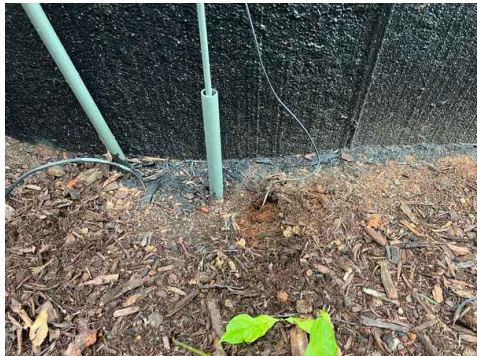
RIGHT SIDERIGHT SIDE

Unable to confirm proper grounding of the home because no ground rod was found at the main grounding wire. Grounding used to be connected to waterlines underneath the soil, but that is no longer an effective grounding method because of pipe materials changing from copper to plastic or other materials which break the ground path. If proper ground is not established it could result in a shock hazard. Recommend further evaluation by a licensed electrical contractor.

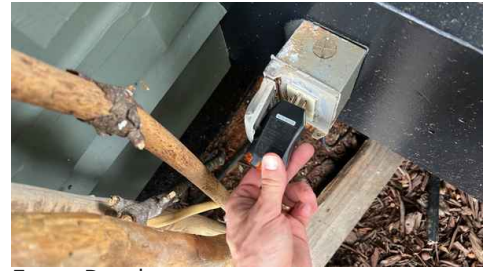
Front Porch

ELECTRICAL RECEPTACLE OBSTRUCTED

Weather cover obstructed the outlet tester from access. Recommend further evaluation by a licensed electrical contractor.

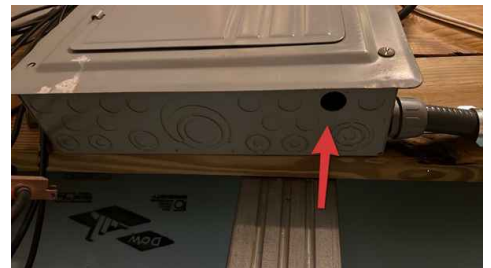
6.2.1 Main & Subpanels, Service & Grounding, Main
Overcurrent Device

**Major Defect****KNOCKOUTS MISSING**

"Knockouts" are missing on the electric panel. This can allow pest, debris and fingers into the panel which poses a safety hazard. Recommended that the opening in the panel caused by the missing knockout(s) be properly sealed by a licensed electrical contractor.

Contact a qualified electrical contractor.

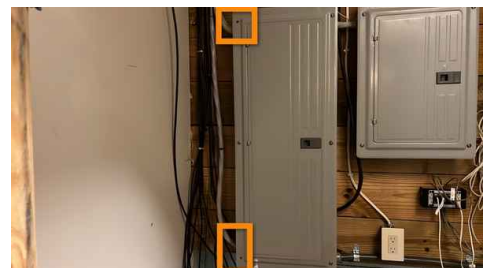
6.2.2 Main & Subpanels, Service & Grounding, Main
Overcurrent Device

**Minor Defect****MISSING SCREWS**

Electrical panel screws were found to be missing at the time of inspection. Missing screws can allow moisture, debris, or pests to enter the panel, potentially leading to corrosion or damage to internal electrical components. Recommend correction by a licensed electrical contractor to restore the panel's integrity and ensure safe operation.

Contact a qualified electrical contractor.

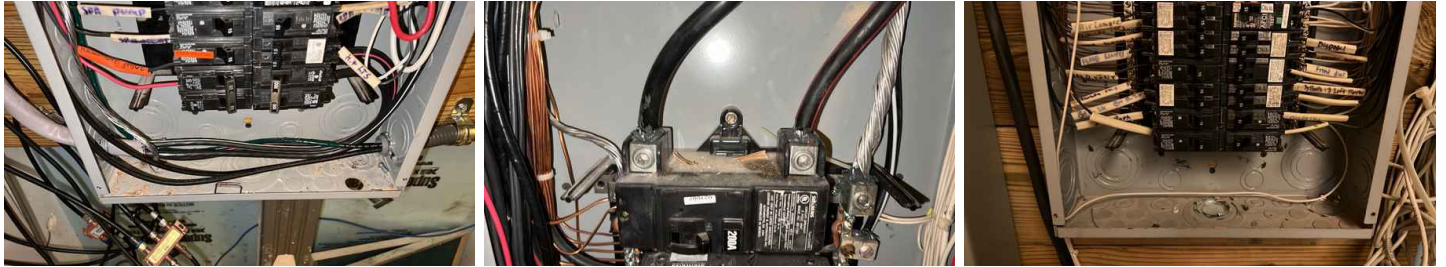
6.2.3 Main & Subpanels, Service & Grounding, Main Overcurrent Device

Debris was discovered inside the electrical panel during the inspection. The presence of foreign materials creates potential electrical hazards and can interfere with proper circuit performance. This accumulation increases risks of short circuits, overheating, and potential electrical system malfunction. Recommend cleaning out the panel by a licensed electrical contractor and ensuring no compromised components are present.

Contact a qualified electrical contractor.

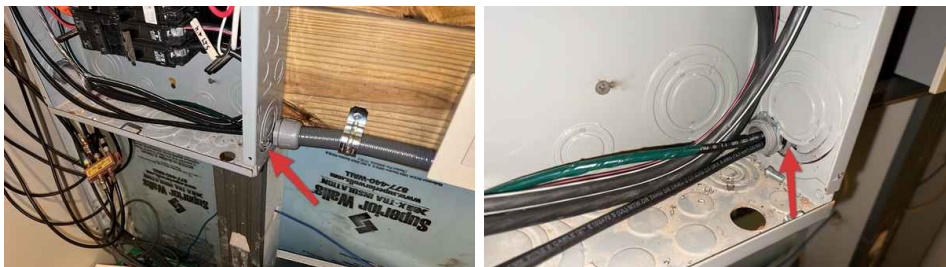
6.2.4 Main & Subpanels, Service & Grounding, Main Overcurrent Device

IMPROPER KNOCKOUT USE

Improper wire installation into the main panel was observed. The electrical conduit on the bottom right side of the main panel was installed by removing the outside knockout ring instead of using the inside smaller rings which are typically used for smaller sized conduits. This damaged some of the other rings at the "knockout" which formed an opening into the panel. This opening can allow pest or debris entry which can damage the internal components. Recommend further evaluation and correction by a licensed electrical contractor.

Contact a qualified electrical contractor.

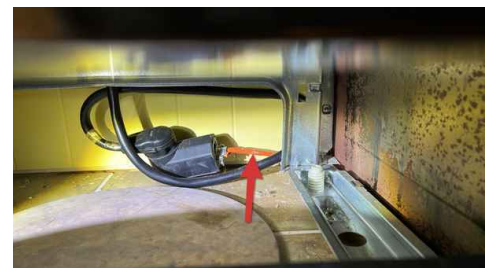
Behind Basement Kitchen Oven

EXPOSED "ROMEX" WIRING

Exposed NM (non-metallic) 'Romex' electrical wiring was discovered during the inspection. This type of wiring is only allowed to be exposed in areas that were it is not subject to physical damage like, unfinished basements, crawlspaces, attics and 7ft above the floor of unfinished garages. The current condition is a safety hazard as exposed electrical cables can lead to potential wire damage, electrical fires, or shock. Electrical wiring must be properly enclosed and protected to prevent accidental contact and reduce safety risks. Further evaluation and correction by a licensed electrical contractor is recommended to ensure electrical system safety.

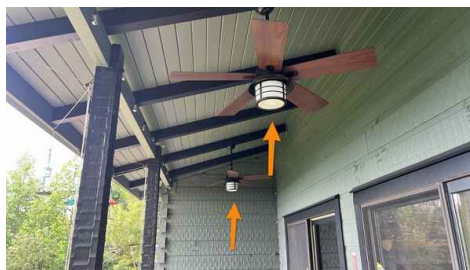
A light fixture was found to be non-functional during the inspection. This condition may be due to a faulty bulb, loose wiring connection, or a more complex electrical issue. The various nature of the defect can pose potential shock and safety hazards. Non-operational electrical components should be evaluated to ensure safe and proper functionality. If changing the light bulb does not resolve the issue, then further evaluation and correction by a licensed electrician is recommended.

Fans did not work either

Contact a qualified electrical contractor.

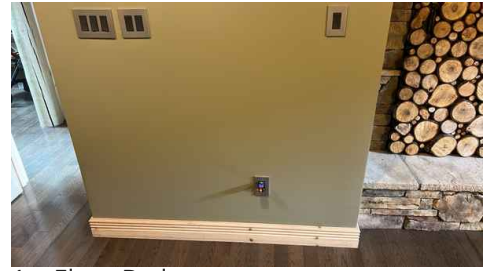
1st Floor Bedroom

Reverse polarity in electrical outlets occurs when hot and neutral wires are incorrectly connected. This wiring error was discovered during the electrical system inspection. Reversed polarity can lead to increased risk of electrical shock and potential damage to connected devices. Recommend further evaluation by a licensed electrical contractor.

Contact a qualified electrical contractor.

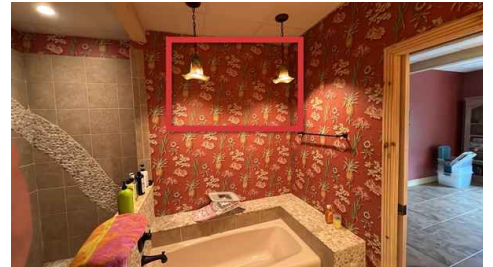
6.4.3 Lighting Fixtures, Switches & Receptacles

IMPROPER LIGHTING INSTALLATION OVER PLUMBING FIXTURE

A pendant light fixture was observed within 3 feet horizontally or 8 feet vertically from the edge of the shower. This type of light fixture is not rated for installation in this location and can present a shock hazard. Recommend further evaluation and correction by a licensed electrical contractor to ensure safe and proper installation.

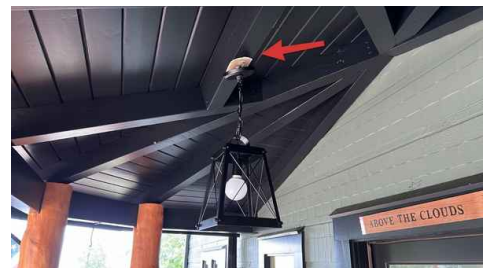
6.4.4 Lighting Fixtures, Switches & Receptacles

EXPOSED WIRING AT LIGHT FIXTURE

Exposed electrical wiring was discovered at a light fixture during inspection. This creates a potential shock hazard. Recommend correction by a qualified electrical contractor to ensure safety.

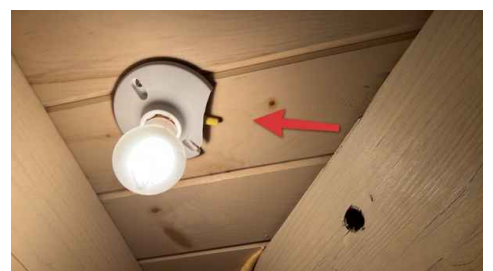
Knee wall

EXPOSED WIRING AT LIGHT FIXTURE 2

The light fixture at the front porch was not properly secured and had electrical wire exposed. This is a shock hazard. Recommend correction by a qualified electrical contractor.

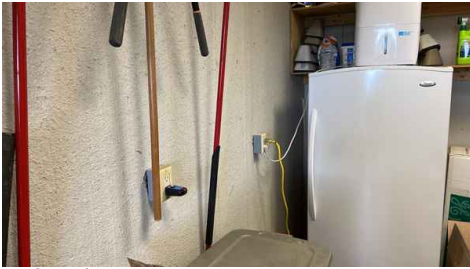
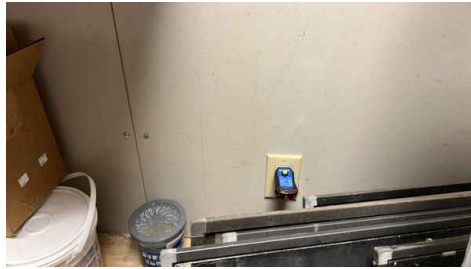
Left Side Basement Exterior Storage Room

Electrical receptacles without power indicate a potential electrical system malfunction. During inspection, no electrical current was detected at multiple receptacle locations. This creates significant safety concerns and prevents normal electrical device operation. Recommend further evaluation and correction by a licensed electrical contractor. immediate electrical system evaluation by a licensed electrician to diagnose and resolve the underlying power distribution issue.

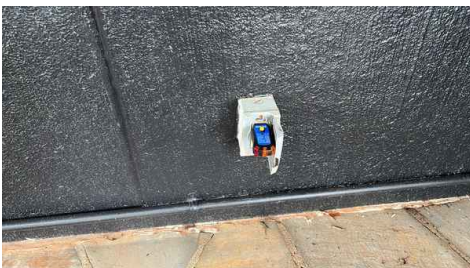
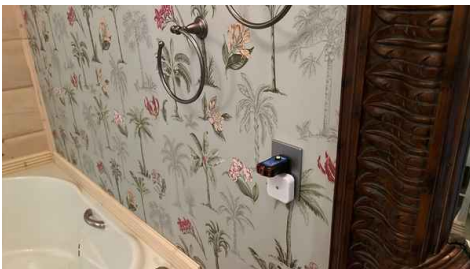
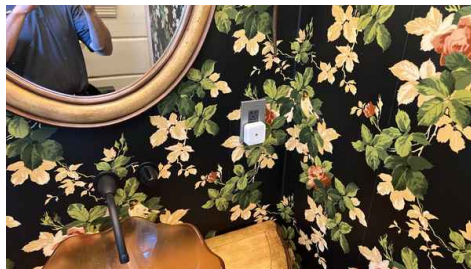
Multiple GFCI receptacles did not reset after being tested. This is a failed test and there could be further underlying electrical issues which are not able to be observed at this inspection. Recommend further evaluation and correction by a licensed electrical contractor.

Contact a qualified electrical contractor.

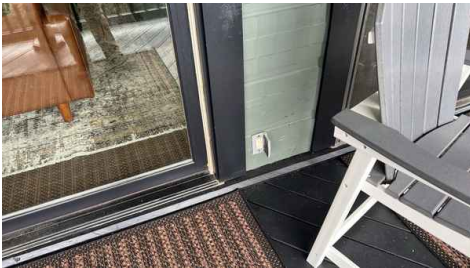
1st Floor Deck

TRIPPED RECEPTACLE

This receptacle was tripped before any testing. The receptacle was able to be reset once but not a second time and remained tripped. This indicates a further electrical issues and can be a potential shock hazard. Recommend further evaluation and correction by a licensed electrical contractor.

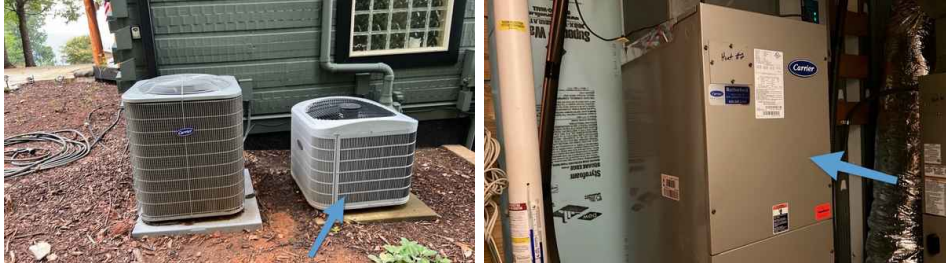
NEAR END OF LIFE EXPECTANCY

The heating system is close to being older than the typical 15–20 year life expectancy. Older systems can be less reliable, less efficient, and more likely to need repairs. Recommend monitoring and planning for replacement when needed.

Built in 2007

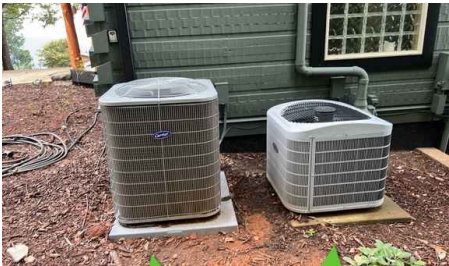
Left Built 2025, Right Built 2007

Cooling Equipment: Cooling Type
Heat Pump, Central Air (Split System)

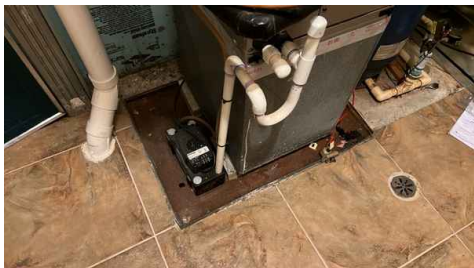
RUSTED CONDENSATE DRAIN PAN

Rust was observed in the condensate pan beneath the cooling system. This condition indicates corrosion from prolonged moisture exposure and can weaken the pan, increasing the risk of leaks and water damage to surrounding areas. Rust may also be a sign of improper drainage or standing water in the pan. Recommend evaluation and repair or replacement of the condensate pan by a qualified HVAC professional to ensure proper operation and prevent potential water damage.

Contact a qualified HVAC professional.

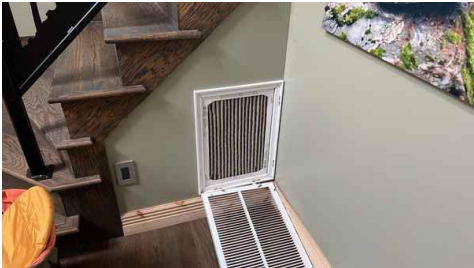
1st Floor Entryway

DIRTY AIR FILTER

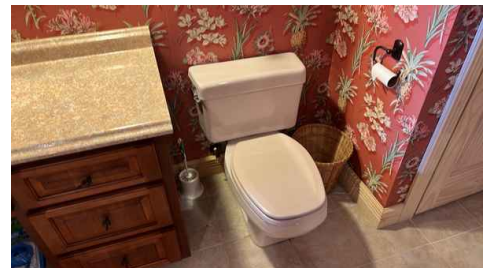
Basement Bathroom

LOOSE TOILET

The toilet is unstable and not securely fastened to the floor. This was discovered during the plumbing system inspection. An unsecured toilet can cause water leakage, potential floor damage, and create a safety risk for users. Further evaluation and correction by a qualified plumbing contractor is recommended ensuring a stable and watertight installation.

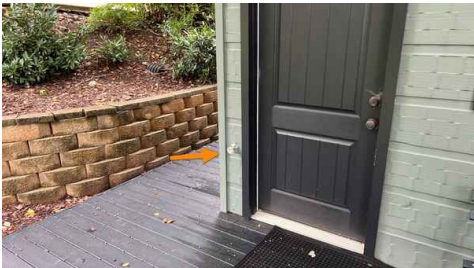
No water was detected at a plumbing fixture during the inspection. This indicates a potential interruption in the water supply that could have multiple causes, such as a closed main water valve, pipe blockage, or broader water system issues. This condition impacts the functionality of the fixture and may indicate a more widespread plumbing system problem. Recommend further evaluation by a qualified plumbing contractor to diagnose and resolve the problem.

Recommendation
Contact a qualified plumbing contractor.

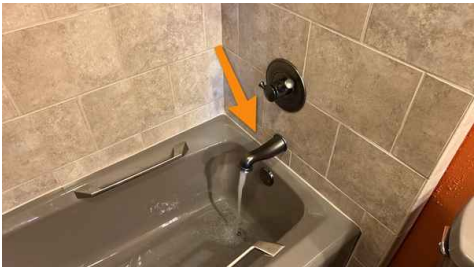
9.3.3 Water Supply, Distribution Systems & Fixtures

LOOSE FIXTURE

A bathroom fixture was observed to be loose and had some movement. This condition can place stress on plumbing connections and may lead to leaks or damage if not corrected. Securing or repair by a qualified contractor is recommended.

Recommendation
Contact a qualified plumbing contractor.

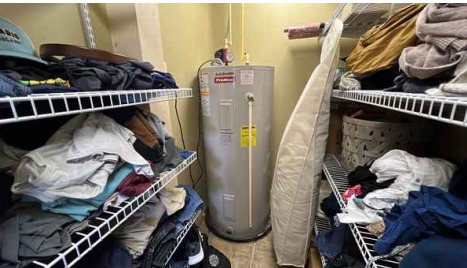
Built in 2006

9.4.1 Hot Water Systems, Controls, Flues & Vents

BEYOND EXPECTED SERVICE LIFE

The hot water system has exceeded its typical expected operational lifespan. During inspection, components were found to be aging beyond manufacturer and industry standard recommendations. This indicates potential increased risk of system failure, reduced efficiency, and potential water damage from potential leaks or sudden breakdown. Recommend professional evaluation by a plumbing contractor to assess current system condition and develop a replacement or comprehensive maintenance strategy.

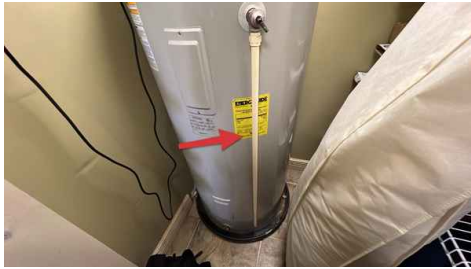
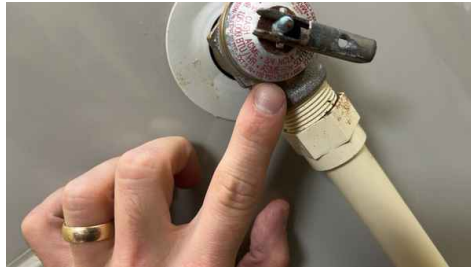
9.4.2 Hot Water Systems, Controls, Flues & Vents

IMPROPER PIPE USED AS TPR DISCHARGE PIPE

The temperature and pressure relief (TPR) valve discharge piping was found to be incorrectly installed with a pipe not rated to sustain the heat and pressure released by the TPR valve. This can cause the pipe to fail if used and is a scalding hazard. Recommend further evaluation and correction by a qualified plumbing contractor.

Contact a qualified plumbing contractor.

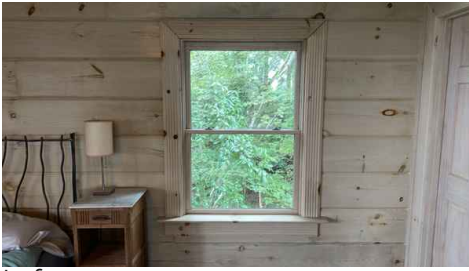
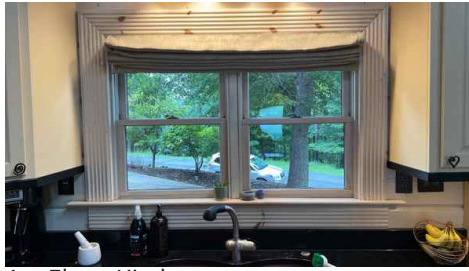
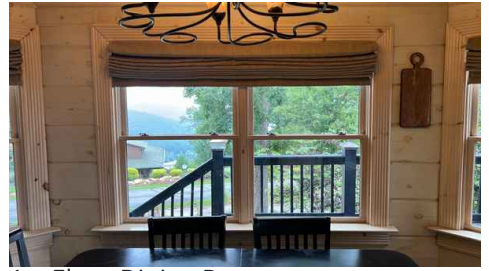
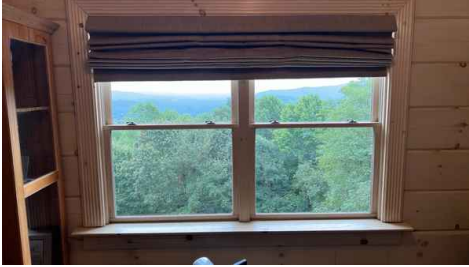
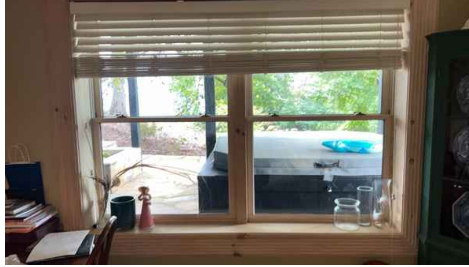
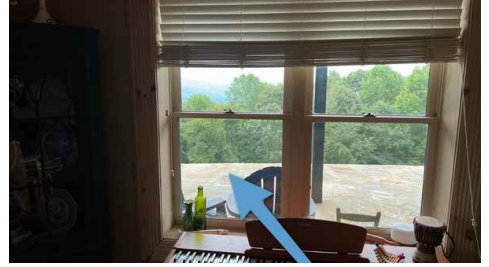
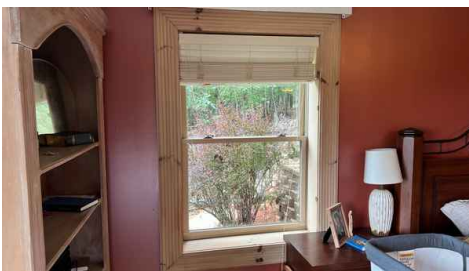
Window experienced operational difficulty during inspection, preventing opening. This indicates potential mechanical issues with window hardware, frame alignment or that it was painted shut. Restricted window movement can impact ventilation, emergency egress, and overall window functionality. Recommend professional window repair to evaluate and correct the window opening problem.

Contact a qualified general contractor.

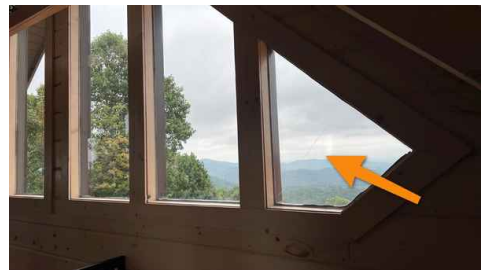
Loft

CRACKED WINDOW

A cracked window was observed during the inspection. Cracks reduce the structural integrity of the glass, increasing the risk of breakage and creating a potential safety hazard. This condition may also contribute to energy loss and allow water intrusion, leading to possible damage. Recommend evaluation and repair or replacement of the cracked glass by a qualified window contractor.

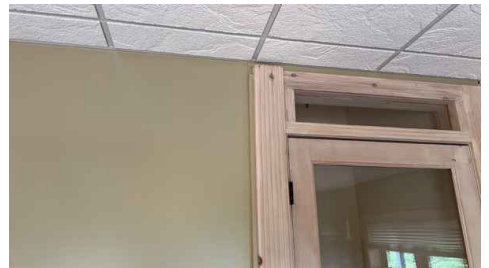
1st Floor Living Room

MINOR CORNER CRACKS

Wall corner cracks were observed at drywall joints. These are common in residential construction and often result from normal settling or minor structural movement; however, in some cases they may indicate underlying structural stress or foundation settlement. Recommend repair of the cracks by a qualified contractor and monitoring for recurrence, with further evaluation if cracks continue to develop.

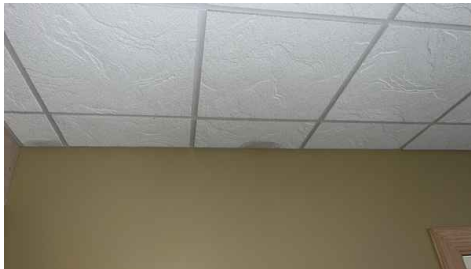
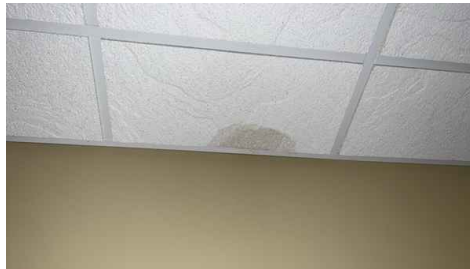
10.5.1 Ceilings

STAIN(S) ON CEILING

A stain was observed on the ceiling, which may be the result of prior or ongoing moisture intrusion. While the area was dry at the time of inspection, stains are indicators of past water entry and possible concealed damage to the ceiling material, insulation, or framing. Further evaluation by a qualified contractor is recommended to determine the source, confirm that the issue has been corrected, and perform any necessary repairs.

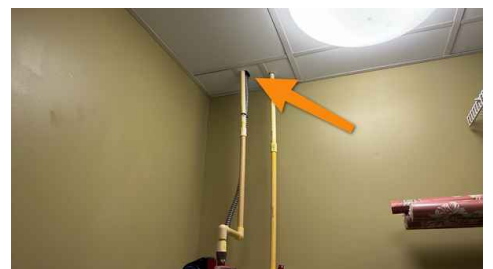
10.5.2 Ceilings

UNSEALED OPENING

An unsealed opening was observed in the ceiling, which may allow the passage of air, moisture, or pests between interior spaces and concealed areas. This condition can reduce energy efficiency. Correction by a qualified contractor is recommended to properly seal the opening.

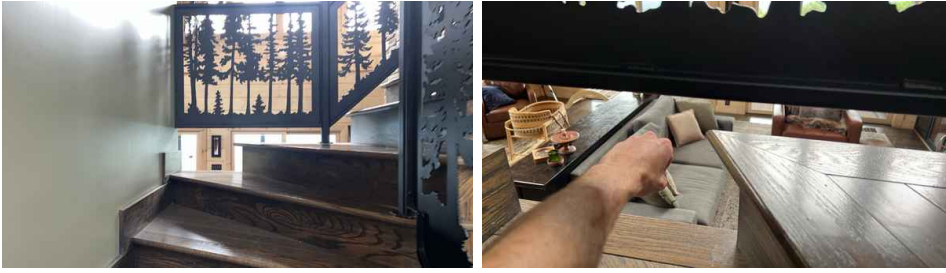
10.6.1 Steps, Stairways & Railings

SPACE BETWEEN STEPS AND HANDRAIL TOO LARGE

The space between the bottom of the handrail and the stair riser is too large. The space is not supposed to be larger than 6 inches in diameter for child safety. The space observed at the entrance way staircase is larger than 6 inches in diameter. This is a fall hazard, especially for small children. Recommend correction by a qualified general contractor.

Contact a qualified general contractor.
