HOME INSPECTION REPORT

874 Summit Pkwy
Bostic , Nc 28018

Nico Toma
08/05/2025

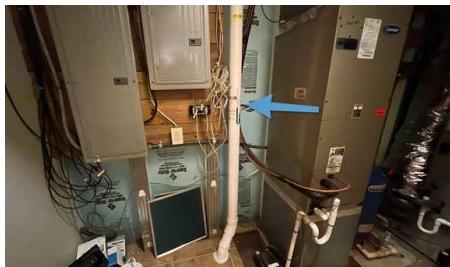
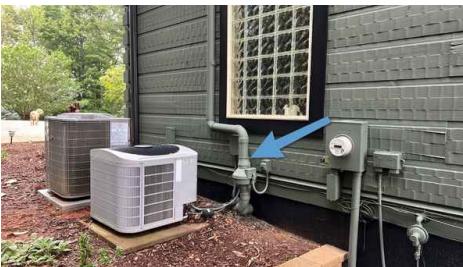
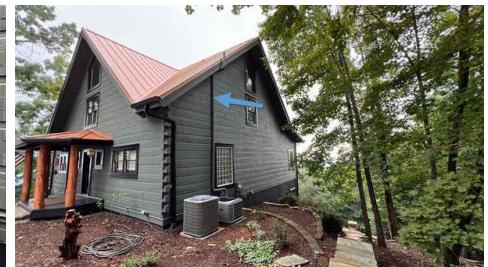
Noted a radon mitigation system was installed in the house. Similar to an HVAC system, radon mitigation systems require annual maintenance and fan service/replacement every 5 years. The inspection of the mitigation system, including the determination of the functionality and/or the effectiveness, is beyond the scope of the home inspection. The homeowner should be asked for more information concerning system warranties and maintenance history. A qualified radon mitigation specialist should be consulted for a complete system evaluation.

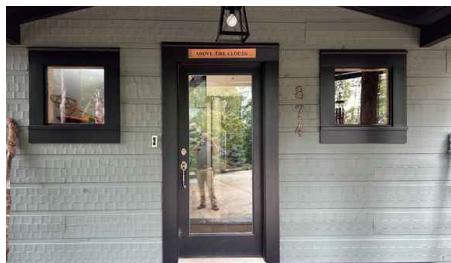
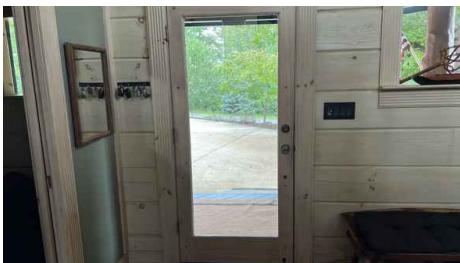
Front doorFront door

Noted door(s) that had a double key deadbolt lock. The deadbolt lock requires a key on the interior to lock/unlock the deadbolt lock. This is allowed but can create fire safety hazards.

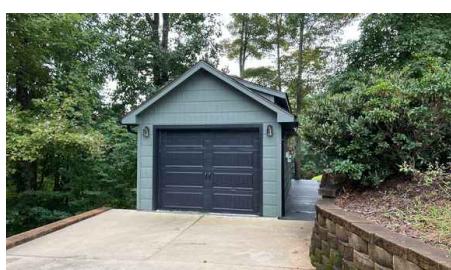
Note this inspection does not include the detached building(s) or any system/component that extended to the detached building(s).

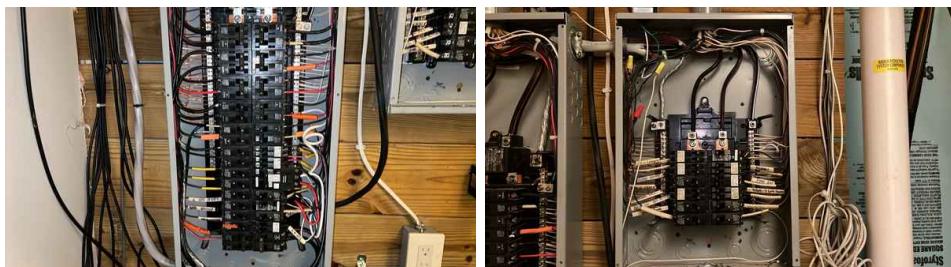
LIMITED VIEW OF CONDUCTORS

There was a limited view of the wires inside the electrical panel(s) due to cut wire insulation for wire identification. This method is used by some electricians for identification purposes but limits the visible view of any damage in the area of wire.

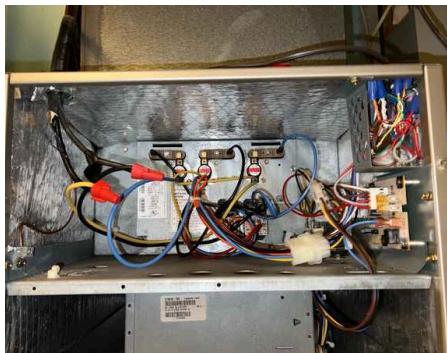
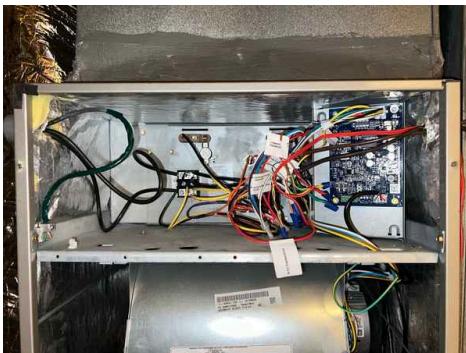
Noted the panel for the burner compartment was removed. The unit was inspected visually.

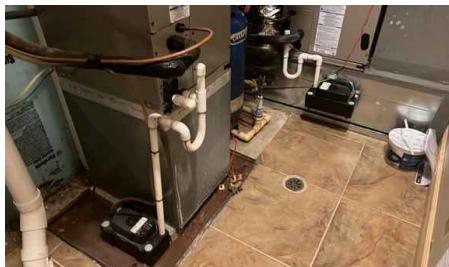
Noted the HVAC unit in the location(s) listed above had its condensation drain piped into a condensate pump that was piped out of the house and its overflow drain had a switch built into the drain pipe. The unit and/or pump were in an overflow pan that had a drain and/or a float switch. The pump may have low voltage wires flowing into it, which would indicate a float switch in the pump. The float switches should turn the AC system off if water builds up in the overflow drain or pan. The float switches were not tested.
